# Proximal Box Elevation With Resin Composite and the Dogma of Biological Width: Clinical R2-Technique and Critical Review

C Frese • D Wolff • HJ Staehle

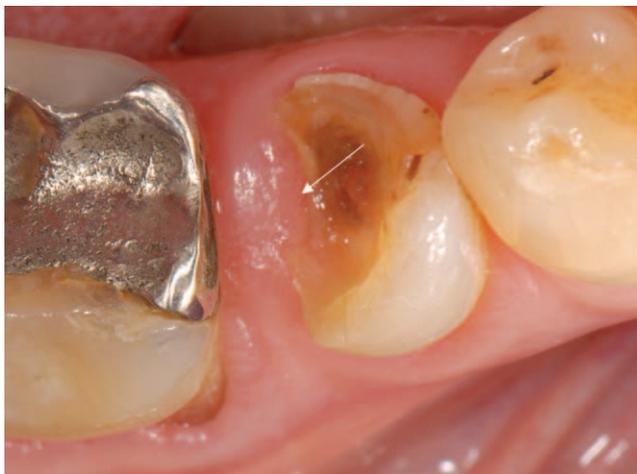
Figure 1. Preoperative view of tooth #45 with occluso-proximal decay and loss of restoration a few weeks before R2-technique was performed. Gingival overgrowth is seen on proximal cavity margin (arrow).

Intraoral evaluation revealed carious decay on the cervical margin of the cavity reaching beyond the CEJ. The proximal margin was partly covered by overgrowing gingival tissue (Figure 1). Radiographic examination of tooth #45 revealed that there was no periapical translucency and that the distance between the cavity margin and the alveolar bone crest was between 0.5 mm and 1.0 mm (Figure 2). As the proximal cavity margin was already beyond the CEJ invading biological width, it was assumed that after caries removal it would be located at the level of the alveolar crest. It was explained to the patient that the gold-standard treatment would be placement of an indirect partial or full crown in combination with surgical or orthodontic pretreatment. Alternatively, it was clarified that if the marginal ridge was still intact, a direct restoration with composite resin could be an option. However, it was also explained that the outcome of this procedure would be less predictable than that of an indirect restoration. The patient favored a restoration with direct composite resin to avoid surgical or orthodontic interventions.

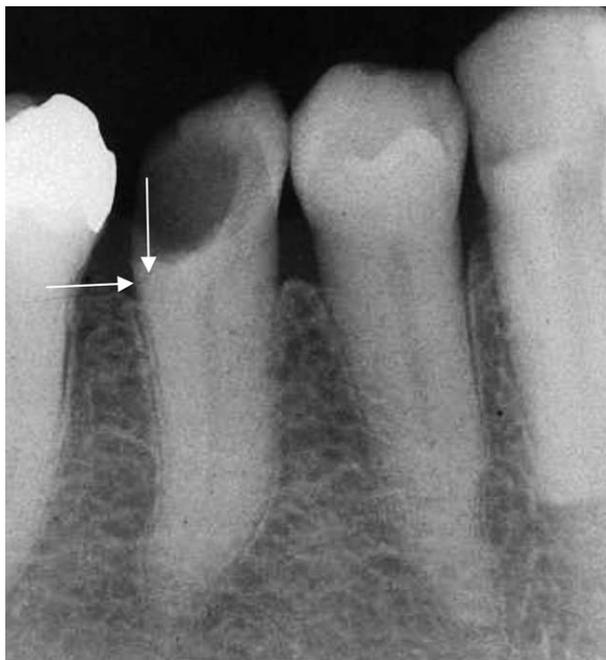
Figure 2. Preoperative x-ray of tooth #45. After excavation of caries, the proximal cavity margin is located close to the alveolar crest (arrow).

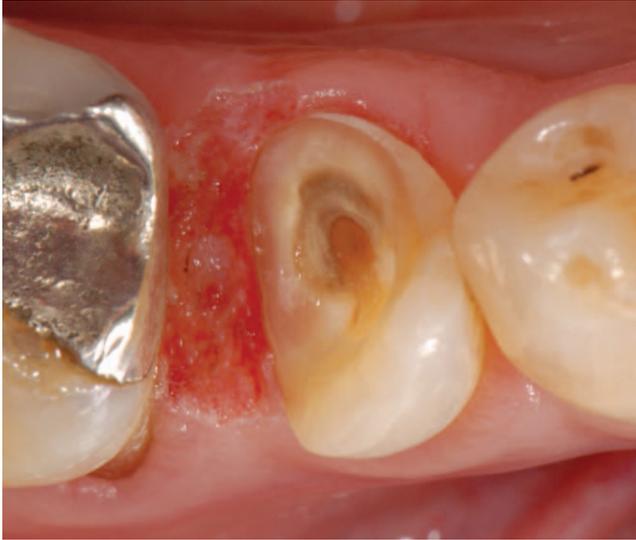
Figure 3. R2-technique: Placement of a direct resin composite restoration in the two-step technique. Step one (PBE): Clinical situation after gingivectomy (Elektrotom) and caries excavation. The proximal cavity margin is located below the CEJ next to the alveolar crest.

angles were rounded. At this point, it was clear that the proximal cavity margin was close to the alveolar crest, making the application of a partial or circular matrix impossible (Figure 3). For hemostasis, a retraction cord was placed and an astringent paste was applied for 2 minutes and rinsed carefully (Astringent Retraction Paste, 3M ESPE, Seefeld, Germany) (Figure 4). Afterward, direct composite resin was applied to perform a PBE in accordance with the protocol of Frankenberger and others<sup>5</sup> and Roggendorf and others<sup>6</sup> (Figure 5). Tooth #45 was etched for 15 seconds with 37% phosphoric acid, a filled ethanol-based adhesive system (Optibond FL, Kerr, Orange, CA, USA) was applied and the adhesive was light-polymerized for 20 seconds (Bluephace C8, Ivoclar, Vivadent, Schaan, Liechtenstein). A thin layer of flowable composite resin (Tetric Evo Flow, Ivoclar Vivadent) was placed on the cavity margin. On top of the nonpolymerized layer of flowable resin, another layer of viscous composite resin was applied (Tetric Evo Ceram, Ivoclar Vivadent). The viscous material was molded and gently pressed into the flowable resin (Snowplough Technique, Figure 6 detailed description *vide infra*).<sup>17</sup> Final polymerization of both the flowable and the viscous composite resin was then completed with light at 800  $\text{mW}/\text{cm}^2$  (40 seconds). Because of the

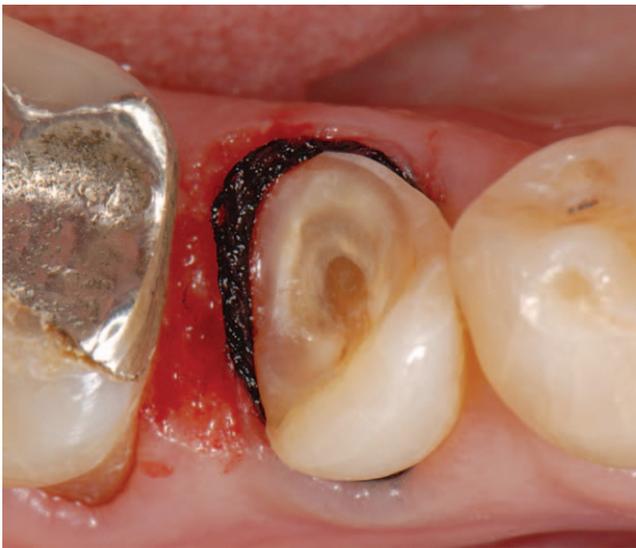
Figure 4. Application of a retraction cord. The cord could not be inserted fully into the sulcus because of the proximity of the alveolar crest. Subsequently, an astringent paste was applied for 2 min.

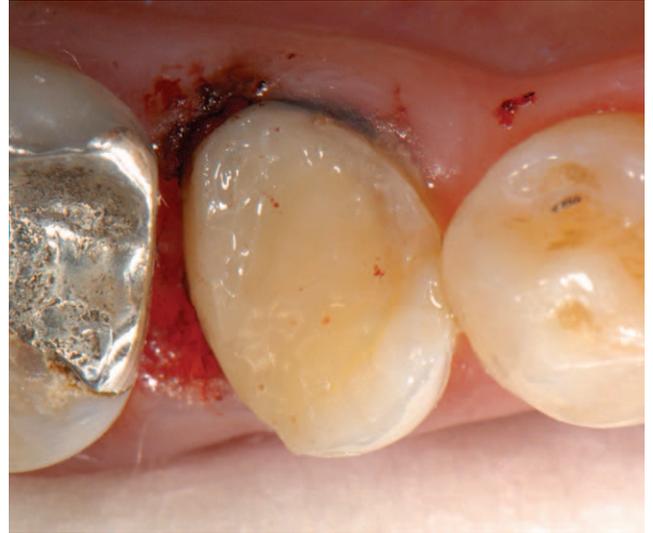
Figure 5. After etching, priming, and bonding, a layer of flowable composite was placed meticulously on the cavity margin, followed by a layer of viscous resin composite (both unpolymerized). After modeling and shaping both materials, the final light polymerization was carried out (Snowplough technique).

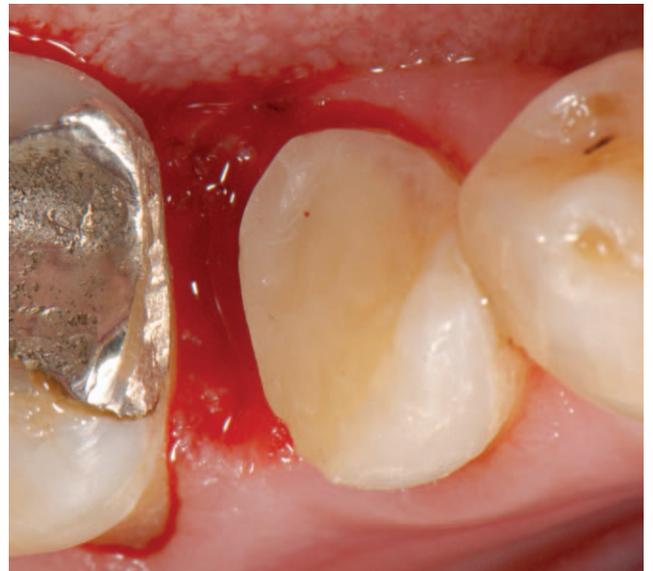
Figure 6. Schematic drawing of Snowplough technique: Note that in clinical practice there is a narrow and sharp angled junction between PBE placed in step one and the sectional matrix.

The composite resin was applied using the Snowplough technique (Figure 6).

The Snowplough technique contributes essentially to achieving a homogenous and nonporous restoration-tooth interface. It is described as the combined use of a flowable composite and a viscous composite resin molded together in an unpolymerized state, followed by final polymerization of both materials (Figure 6).<sup>17</sup>

However in recent years, several new techniques, for example the PBE,<sup>5,6</sup> the elastic cavity wall,<sup>3,4</sup> and the Snowplough technique<sup>17</sup> (Figure 6) were developed to increase clinical success in managing difficult situations. They provide promising approaches to manage complex direct resin restorations on severely decayed teeth. Remarkably, these techniques are mainly designated for building up only parts of teeth, here proximal areas. It is assumed that the violation of the biological width within a limited extent, under the precondition of superior oral hygiene, can be successful. Further experimental and clinical research should be encouraged to gain further information on relevant questions, such as the tolerable extent of violation of the biological width, favorable materials in the subgingival area and their long-term bond strength and surface characteristics, and the evaluation of patient characteristics.

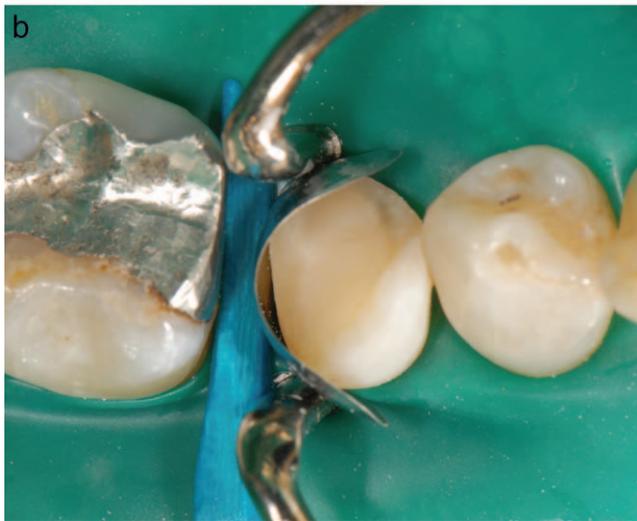
Figure 7. (a) Clinical situation after the PBE. The subgingival restorative margin was finished with rotary diamond instruments and a scalpel to remove overhangs and to create a smooth, planed, and nonirritating surface. (b) Step two: Occlusal view after application of the rubber dam, subsequent sandblasting with aluminium oxide, placement of a sectional matrix, wedging, and application of a separation ring.

abandonment of a matrix, marginal overhangs could not be avoided. Subsequently, they were removed carefully with a rotary diamond instrument #128-130 (Flamme 128-130; Komet, Gebr. Brasseler GmbH & Co.KG) and a scalpel (Figure 7a).

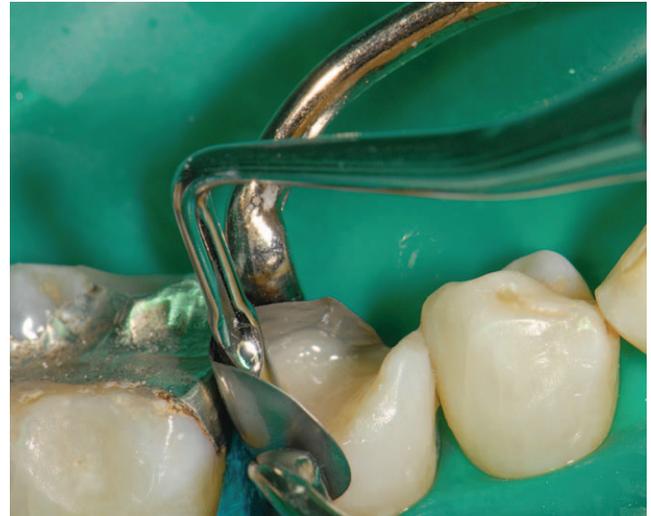
Figure 8. Composite resin is applied using the Snowplough technique. To obtain a tight proximal contact, a special hand instrument was used to separate the teeth during light polymerization.

To obtain a tight proximal contact, a special hand instrument (OptraContact, Ivoclar Vivadent) was used (Figures 8 and 9). Final polymerization of both the flowable and the viscous composite resin was then completed with light at  $800 \text{ mW/cm}^2$  (40 seconds). Finally, the rubber dam was removed, the occlusion was checked, and the restoration was finished using the Astropol HP Finishing Kit (Astropol HP, Ivoclar Vivadent) (Figures 7b through 10). After the treatment session, the patient underwent oral hygiene training, and accurately fitting interdental brushes were chosen (Figure 11).

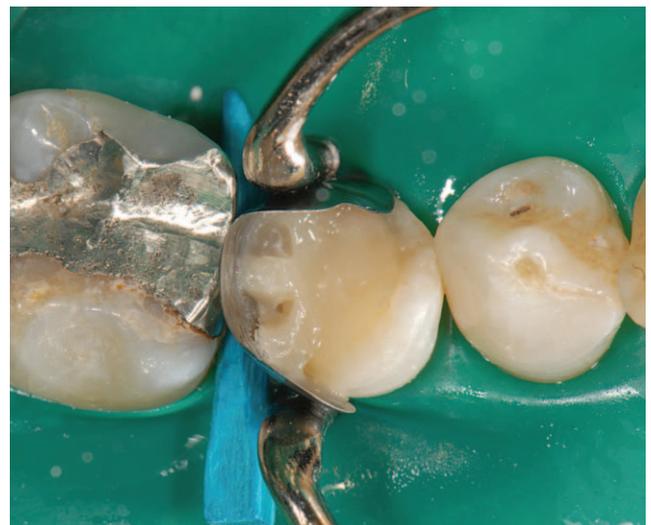
Figure 9. Occlusal view after removal of the proximal contact instrument. A tight proximal contact to the adjacent tooth is accomplished.

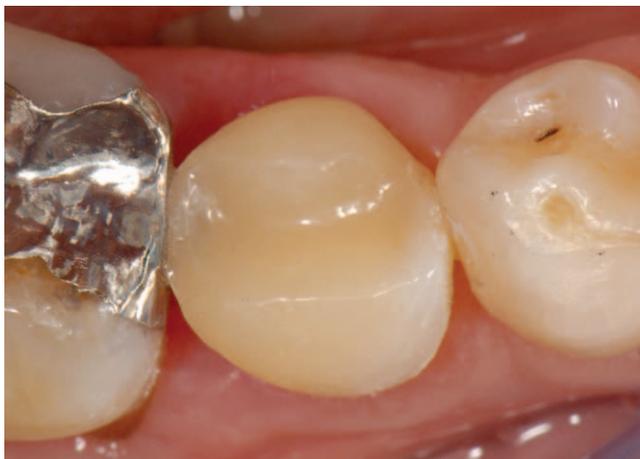
Figure 10. Clinical situation after removal of the rubber dam.

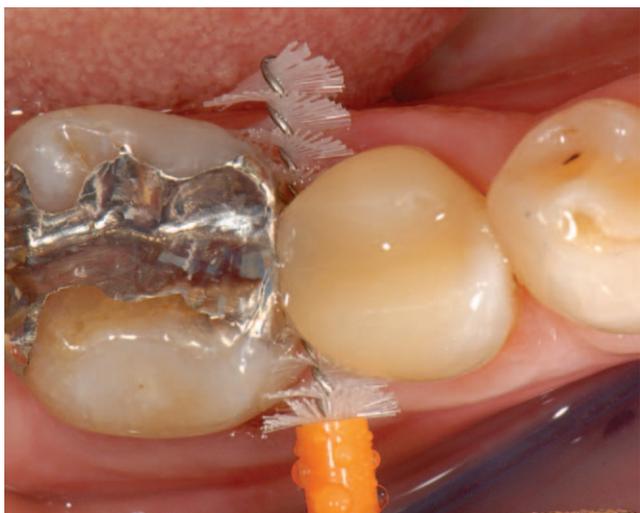
Figure 11. Postoperative view showing the selection of an accurately fitting interdental brush.

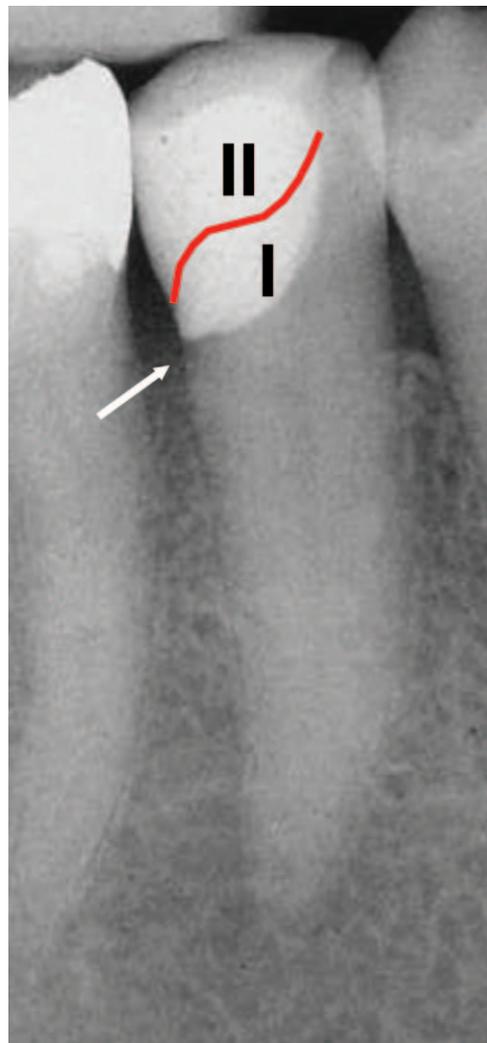
Figure 12. Postoperative x-ray of tooth #45. The subgingival restorative margin invades the biological width (the distance between restorative margin and alveolar crest was 0.5–1.0 mm). The emergence profile of the direct composite resin restoration is anatomically correct. The first part of the R2-restoration (PBE) merges continuously into the second part of the restoration

The postoperative radiographic examination of tooth #45 revealed that the proximal cavity margin was located adjacent to the alveolar bone crest and in close contact to connective tissue fibres of the dentogingival complex (distance 0.5–1.0 mm) (Figure 12).

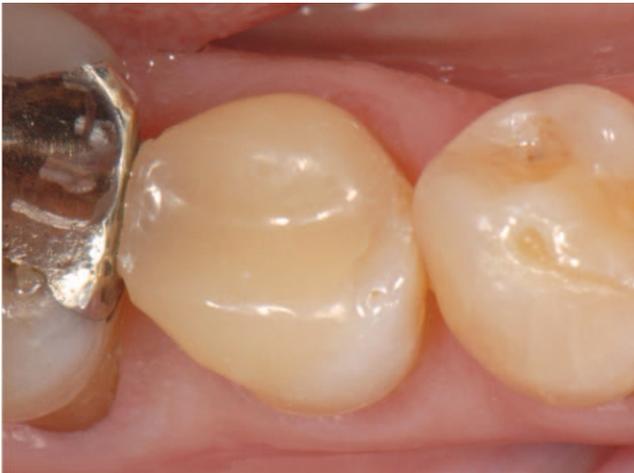
Figure 13. Clinical situation after 12 months: occlusal view.

*12-Month Recall*—The clinical observation after 12 months revealed a vital tooth #45 with no inflammatory signs in the surrounding soft and hard tissue (Figure 13). Despite the fact that the biological width was clearly violated, the probing depths were 2 mm, and no bleeding occurred on probing (Figure 14). Radiographic examination revealed a distance of 1 mm between the restorative margin and the alveolar

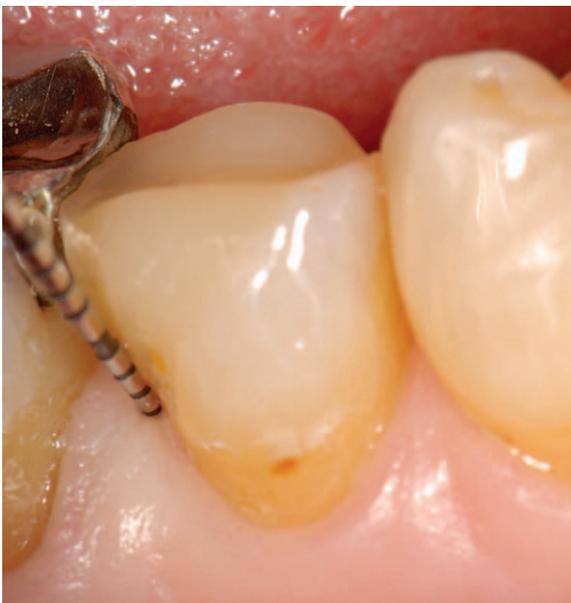
Figure 14. Buccal view after 12 months. The probing pocket depths in the proximal area were 2 mm, and no bleeding occurred on probing.

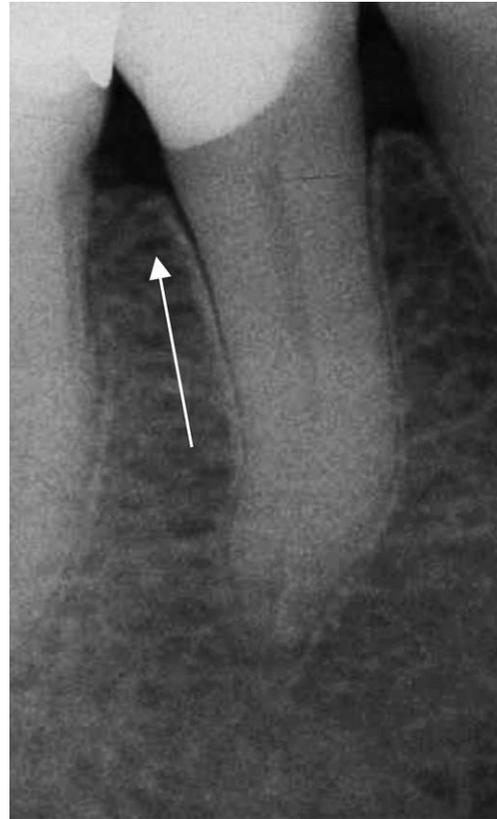
Figure 15. Radiograph of tooth #45 after 12 months. Radiographic examination revealed a distance of 1 mm between the restorative margin and the alveolar crest. Minimal loss of alveolar bone can be observed after 12 months (arrow).

crest. Over the 12-month period, only a minimal loss of alveolar bone was observed (Figure 15).

distortion.<sup>7</sup> At the 12-month follow-up, the radiographic examination revealed a distance of 0.5–1.0 mm between the restorative margin and the alveolar crest with no signs of clinical inflammation.
